### **Critical Habitat Area Wisconsin 7 – Rod and Gun Club Bay**

**Lake Wissota Critical Habitat Designation  
(Site 7)**

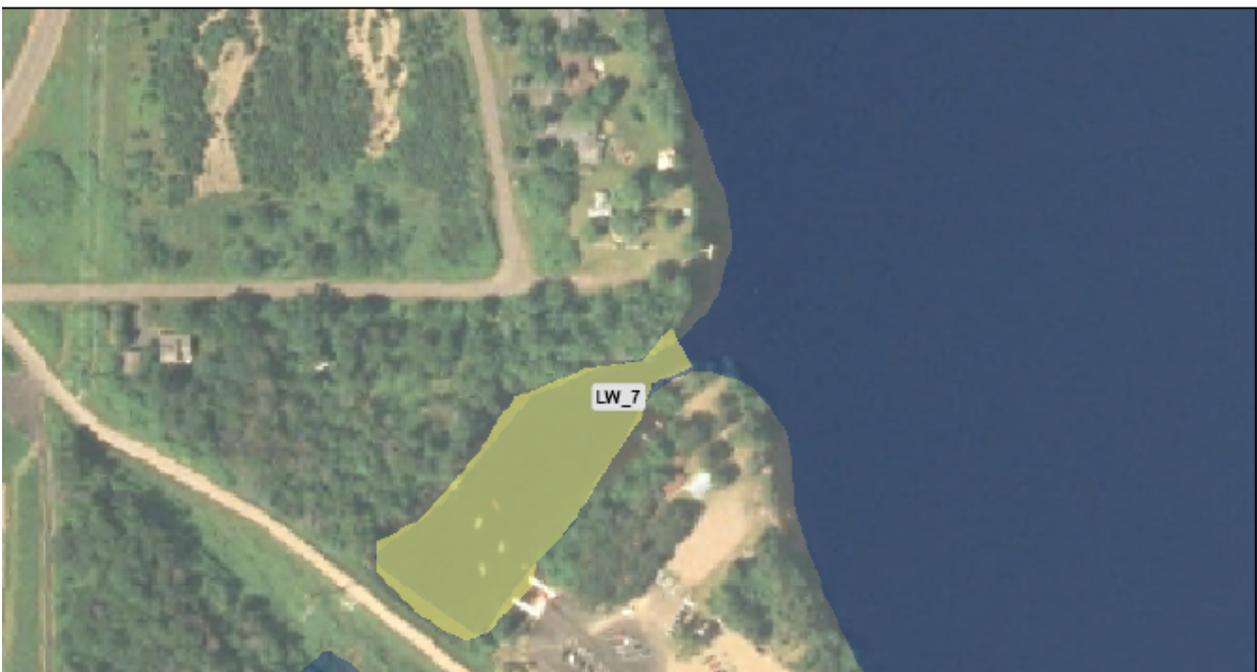
**Figure 6. Lake Wissota Critical Habitat Areas #1, #2, #7, #11, #12, #13**

This Critical Habitat Area encompasses the major portion of a 5-acre bay on the west shore (Figure 6). It includes shallow marsh habitats that support important near-shore terrestrial habitat, shoreline habitat and shallow water habitat (Figure 7, 8). The shoreline at this Critical Habitat Area is composed mostly of wooded cover with a small area of developed lawn and a boat ramp. Large woody cover from fallen trees is common in the shallow water. This woody cover provides important habitat for fish cover and wildlife resting areas.
